LEAD-BASED PAINT RISK ASSESSMENT REPORT

615 W Lasalle Ave
South Bend, IN 46601

Date of Inspection: October 16, 2019

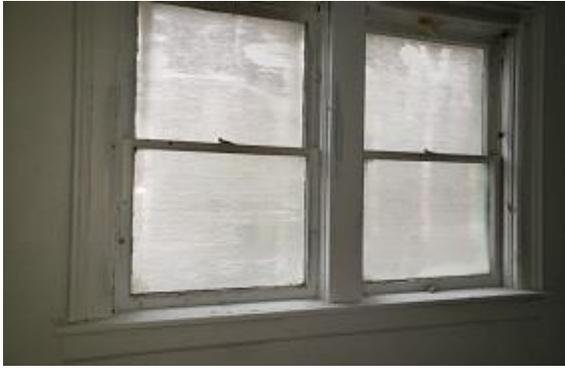
Room 3 window and components B

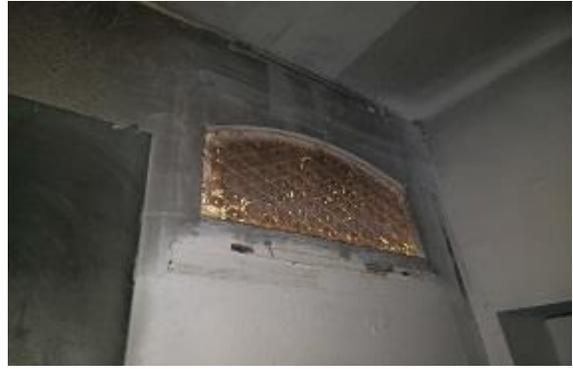
Room 4 dormer window B

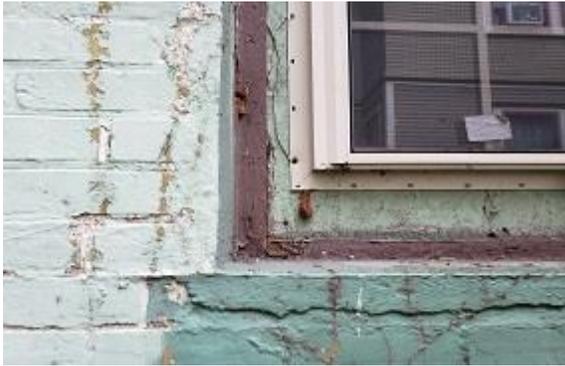
Window casing ABCD

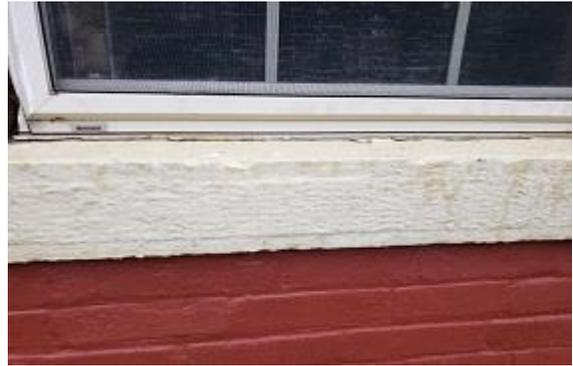
Windowsill ABCD

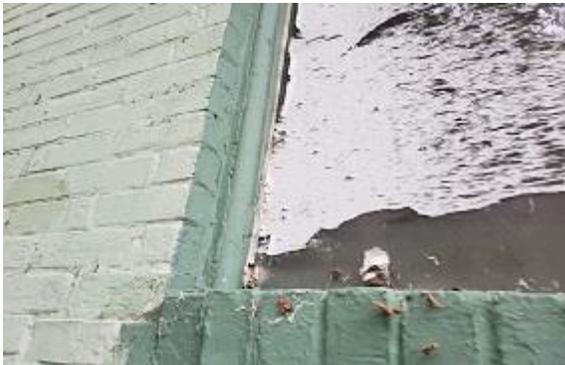
Window casing B

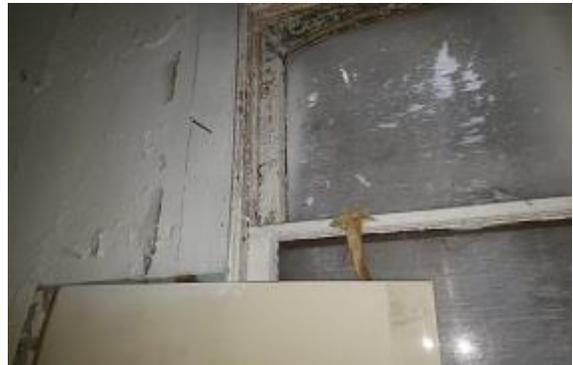
Bathroom 1 window and components B

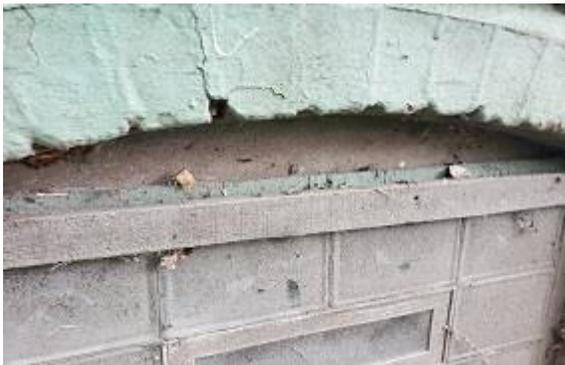
Basement window components BD

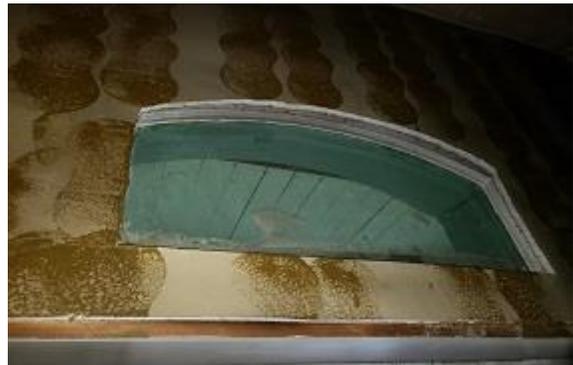
Front entry dormer window A

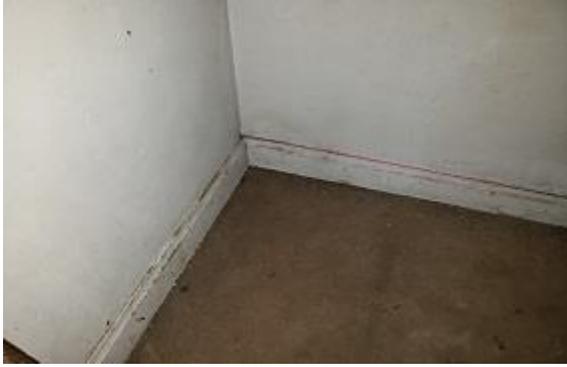
Room 2 closet baseboard

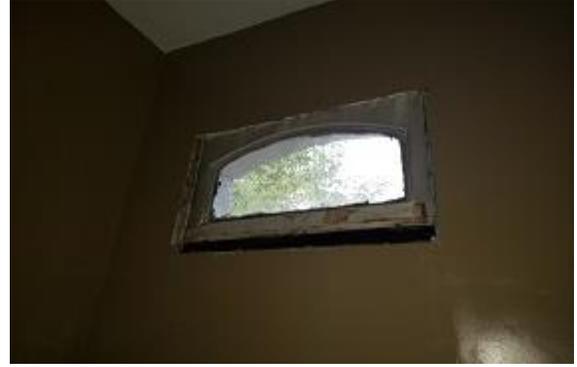
Room 2 dormer window A

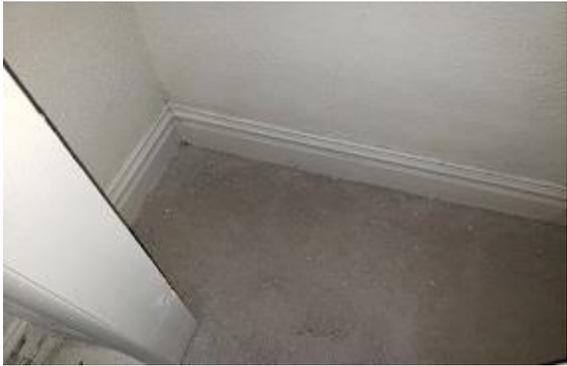
Room 3 closet baseboard

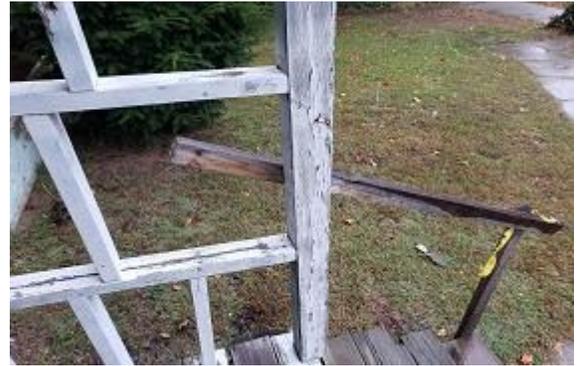
Porch column A

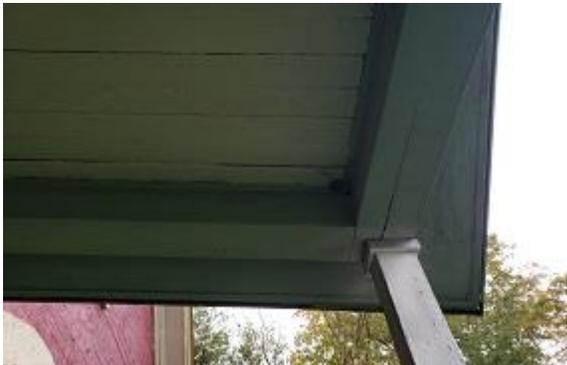
Porch A support beam and ceiling

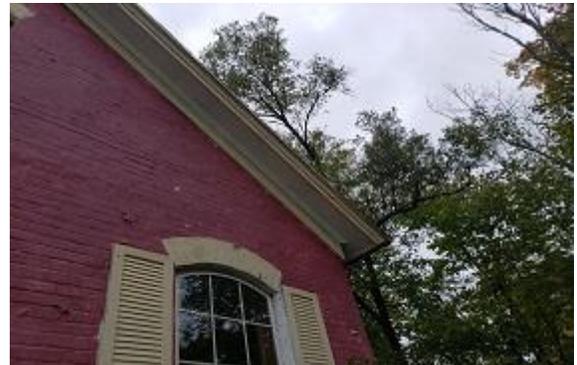
Soffit, fascia, and frieze board ABCD

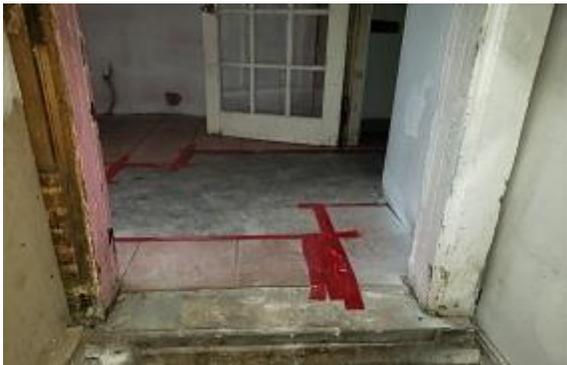
Basement stairs door components D

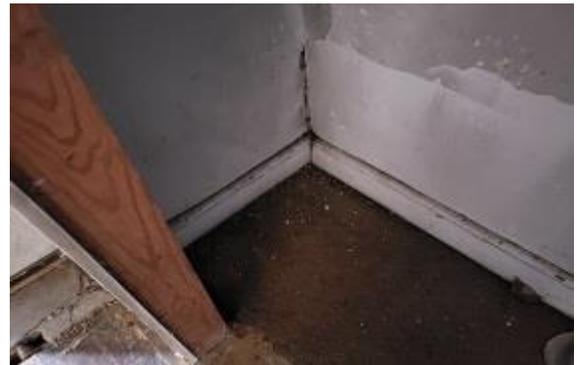
Front entry closet baseboards

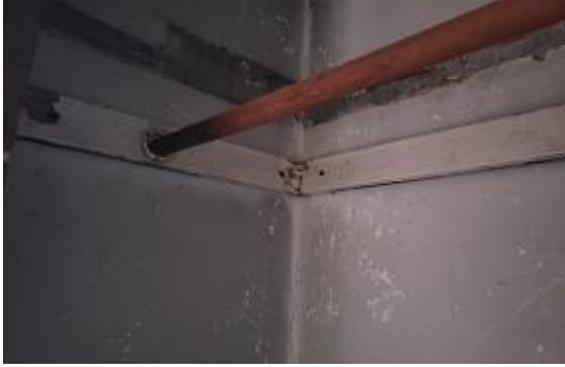
Front entry closet brackets

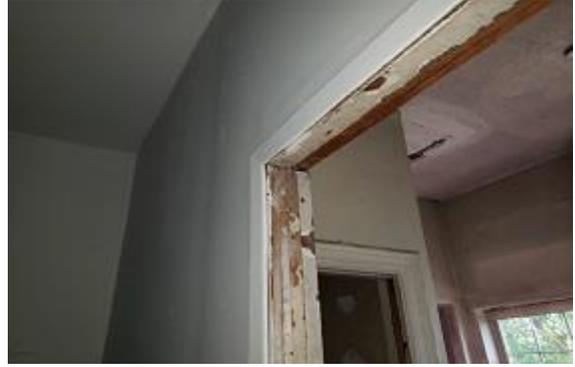
Kitchen door jamb C

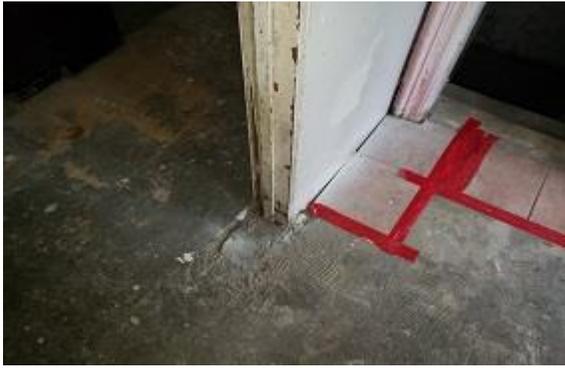
Rear entry door jamb A

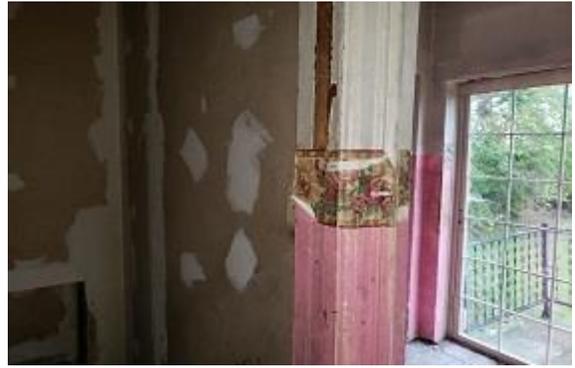
Rear entry door jamb B
