Limited Visual Assessment and Lead-based Paint Inspection

917 W Colfax, South Bend, IN 46601

Inspection Date: March 25, 2022

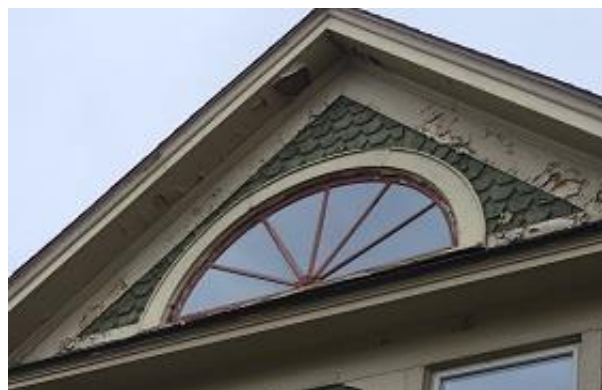
Attic window and components A, Soffit, fascia, and upper trim (assumed positive)

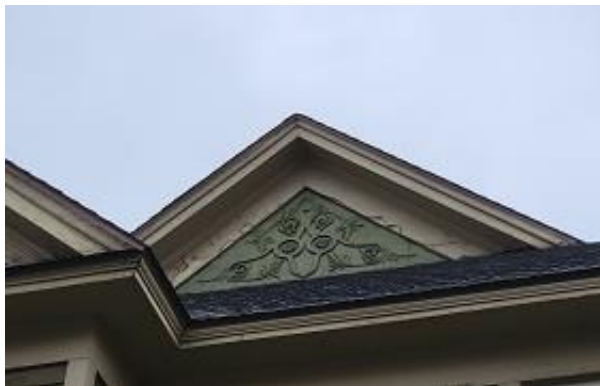
Siding, soffit, fascia, and upper Trim A (assumed positive)

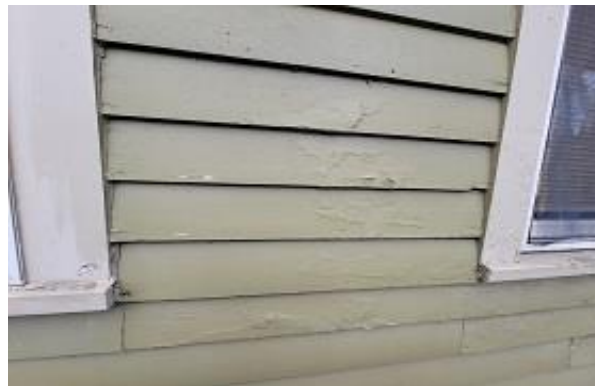
Siding A

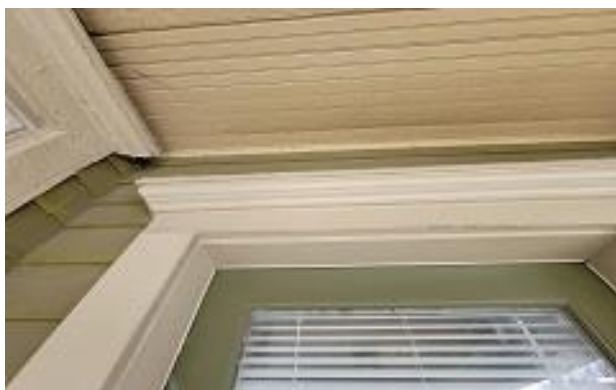
Door header trim A (a)

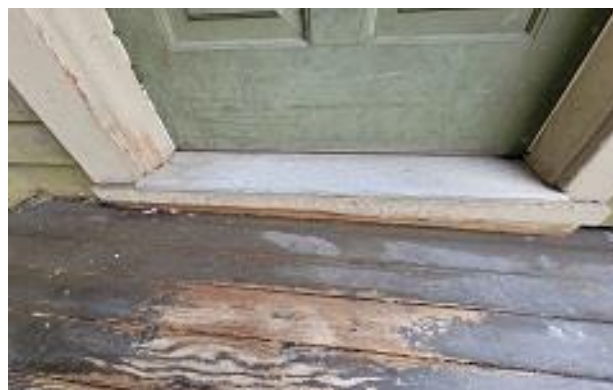
Door threshold A (a)

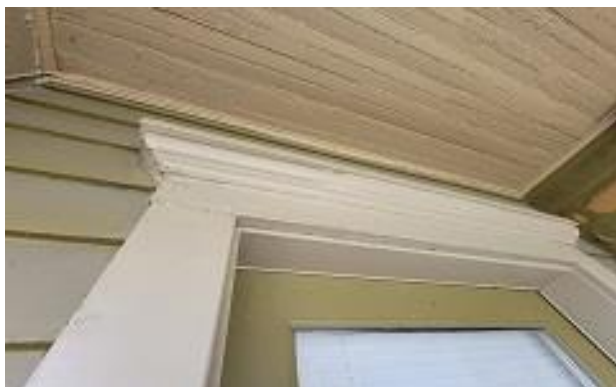
Door header trim A (b)

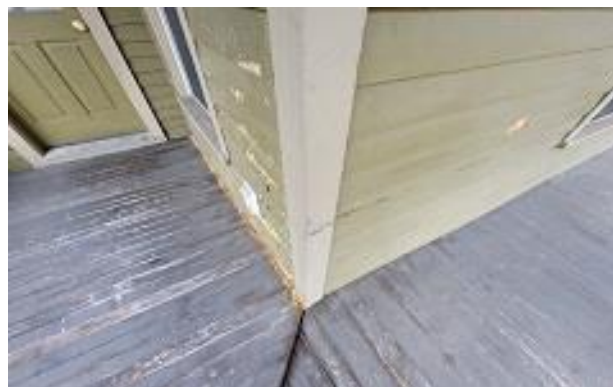
Corner boards ABCD

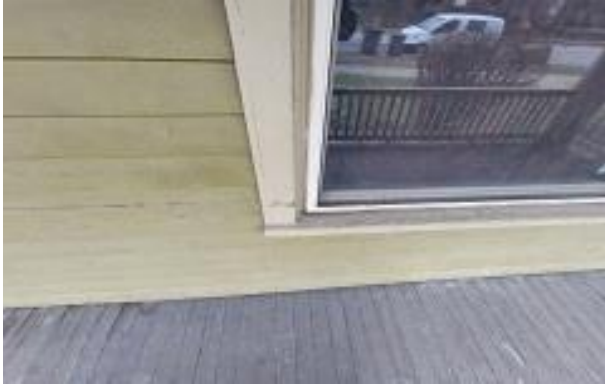
Window casing, sill, and siding ABCD

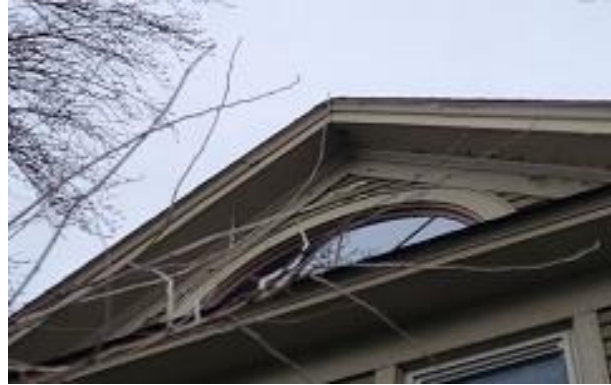
Attic window and casing, soffit, fascia, and upper trim B (assumed positive)

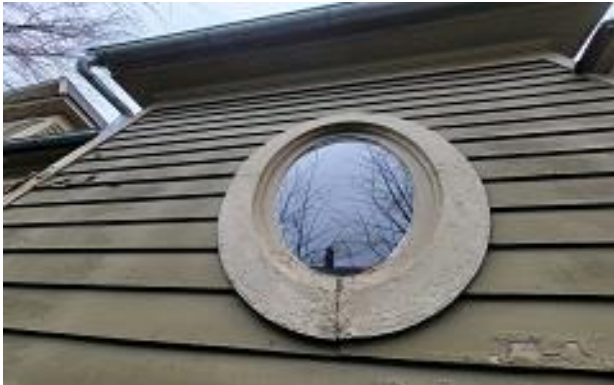
Window and casing B

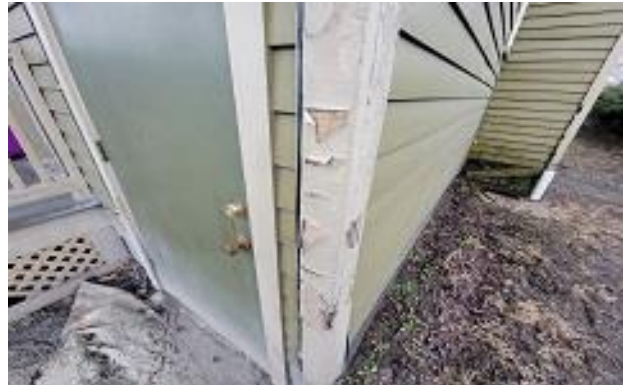
Corner board C

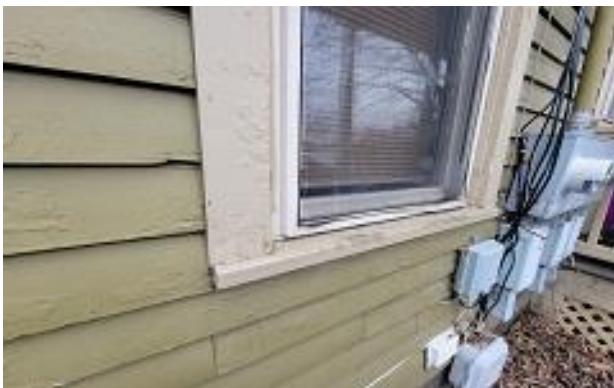
Siding, window casing, and sill C

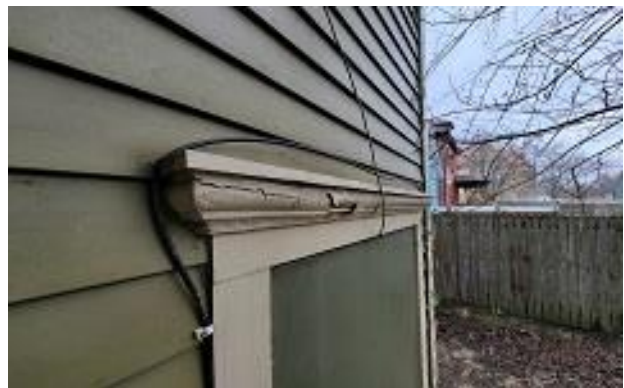
Door header trim C1

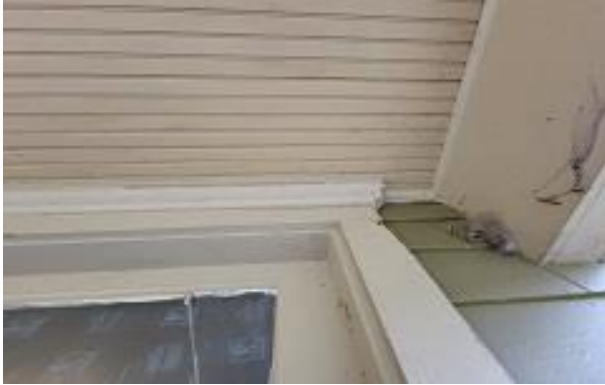
Door header trim C2

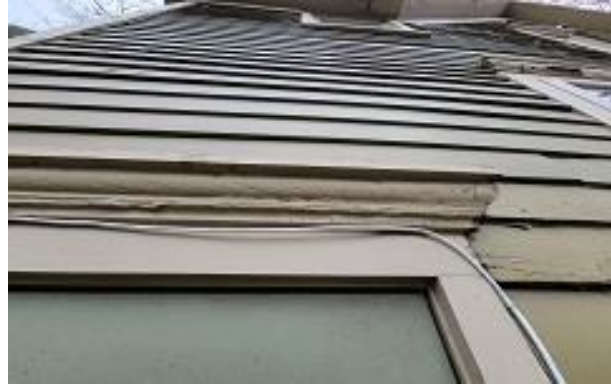
Door header trim C3

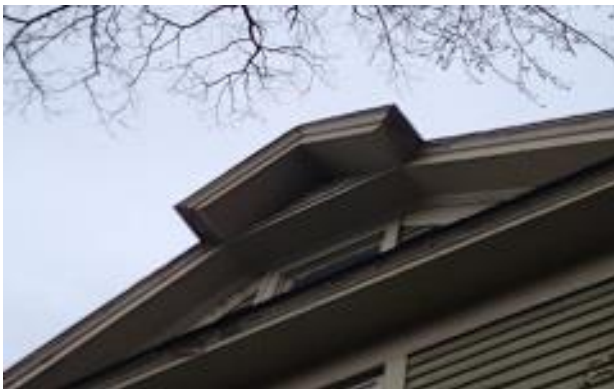
Attic window and casing, upper Trim, soffit, and fascia D (assumed positive)

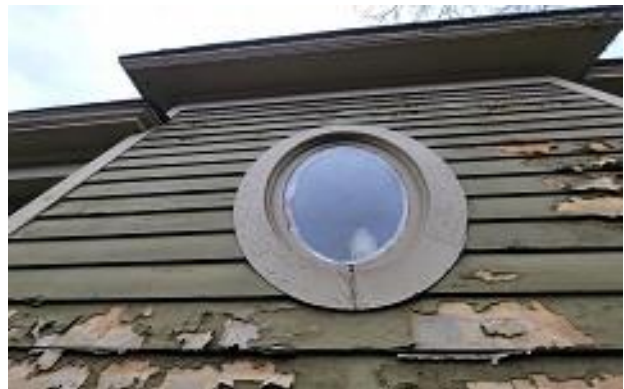
Window and casing D

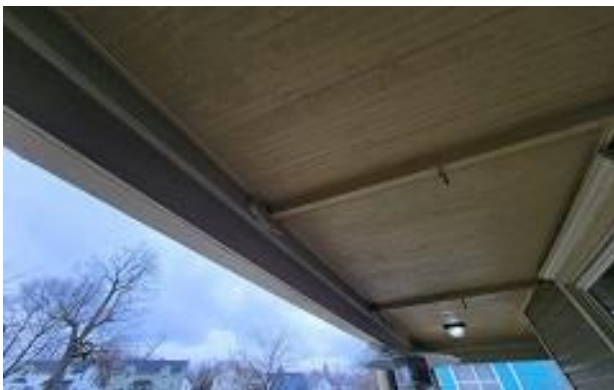
Porch A ceiling

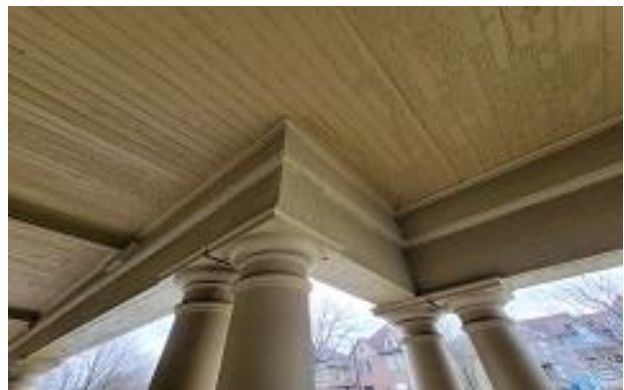
Porch A support beam

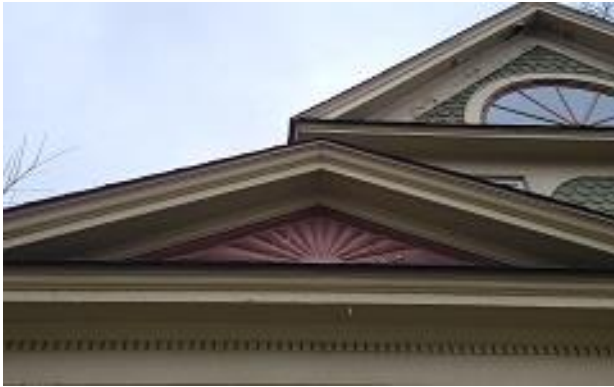
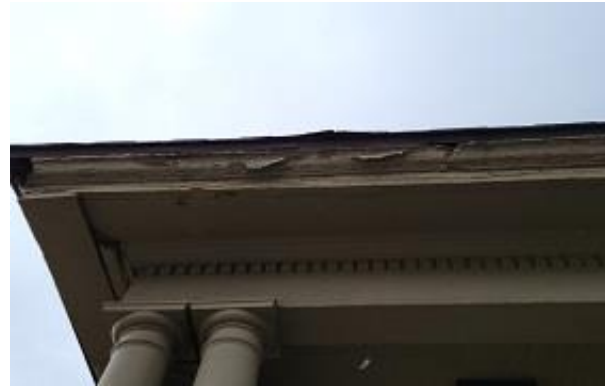
Porch A upper trim, décor, and Siding (assumed positive)
