LEAD-BASED PAINT RISK ASSESSMENT REPORT

**118 N Walnut Street
South Bend, IN 46628**

William C. Center
Certified Lead Risk Assessor #IND000368

Date of Inspection: March 28, 2022

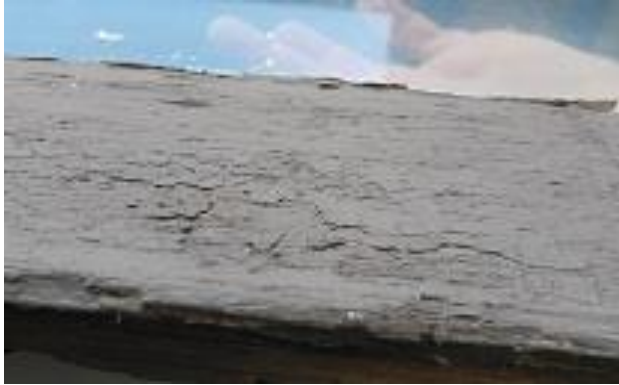
2nd floor exterior window sash ABCD

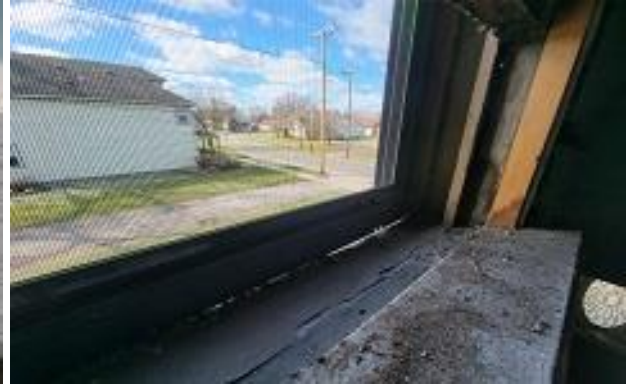
2nd floor exterior window well and track ABCD

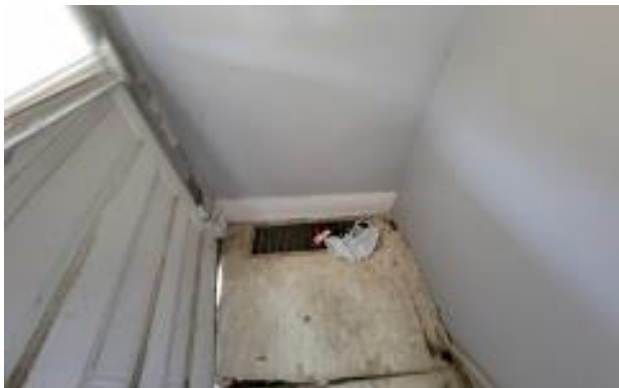
Front entry baseboard

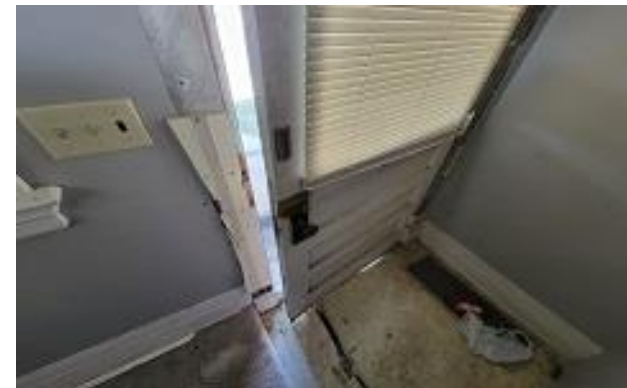
Front entry door and components A and Baseboard

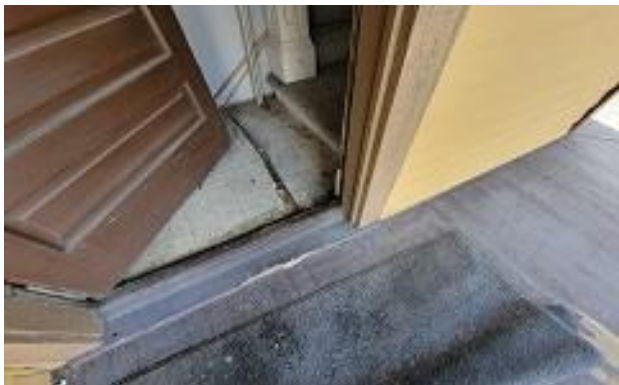
Front entry exterior A door components

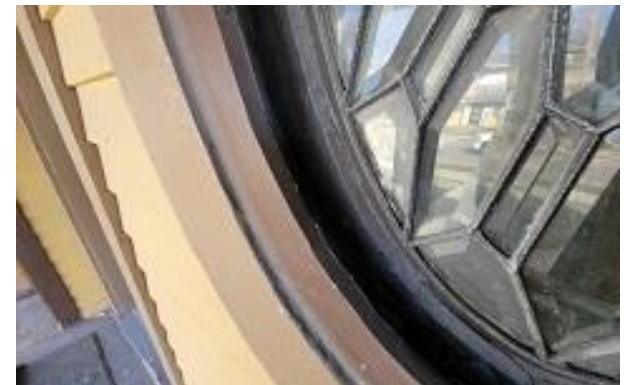
Front entry exterior A window sash

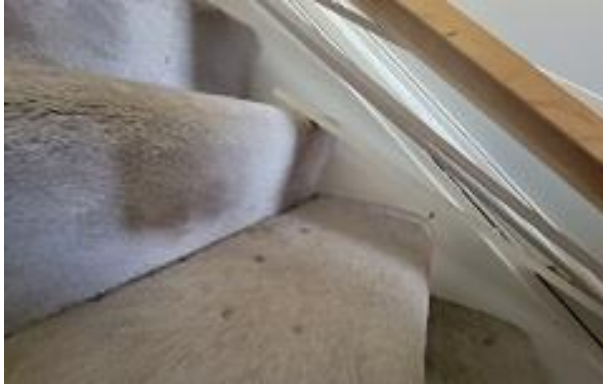
Front entry stair stringers

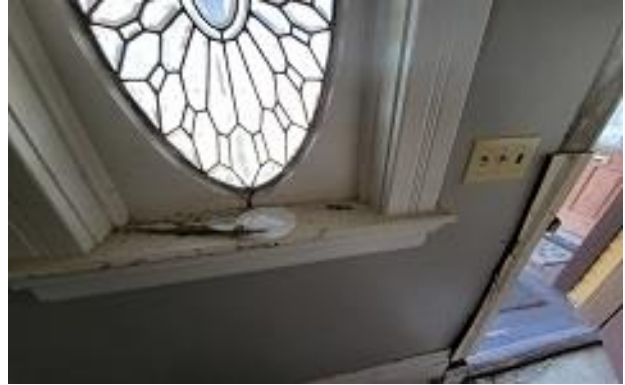
Front entry AD window and components

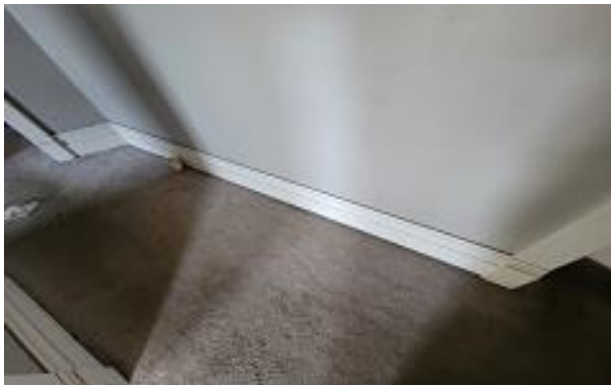
2nd floor stairway baseboard

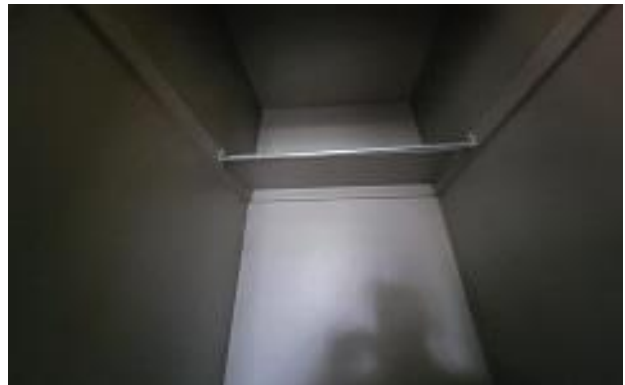
2nd floor stairway closet components

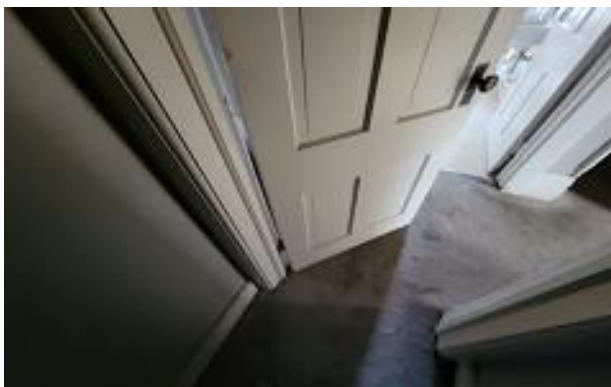
2nd floor stairway closet door and Components

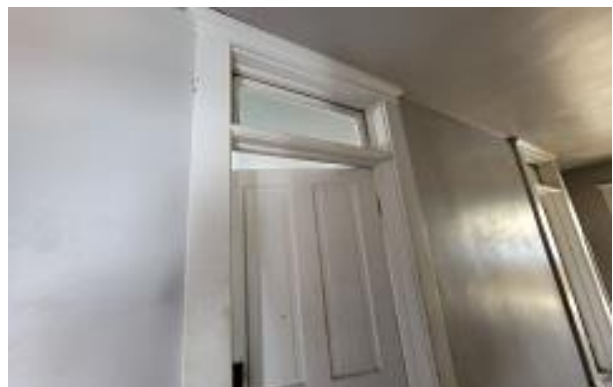
2nd floor stairway door and components including dormer

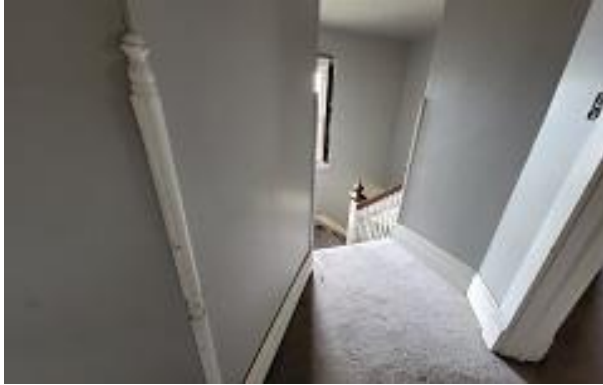
2nd floor stairway trim AC

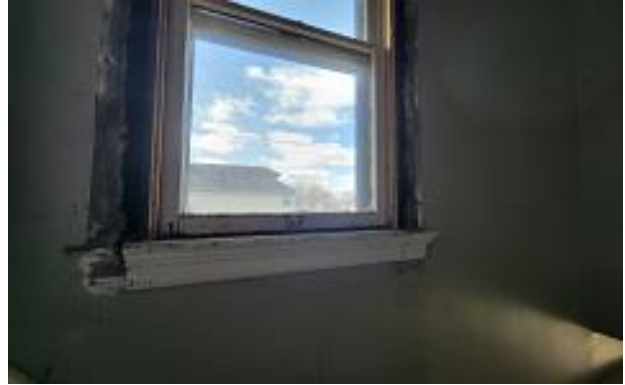
2nd floor stairway window and components

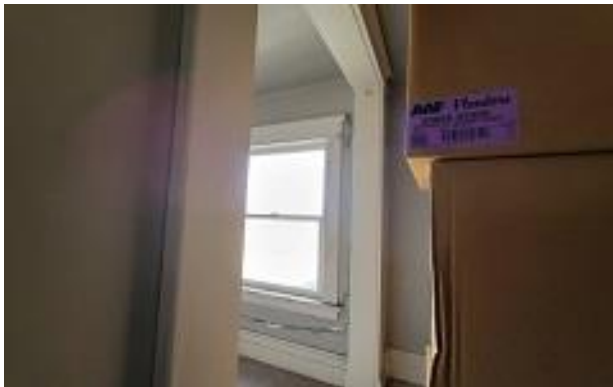
Room 1 arch casing

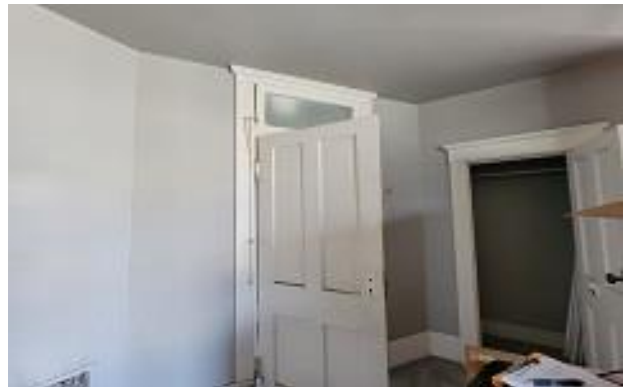
Room 1 door and components C

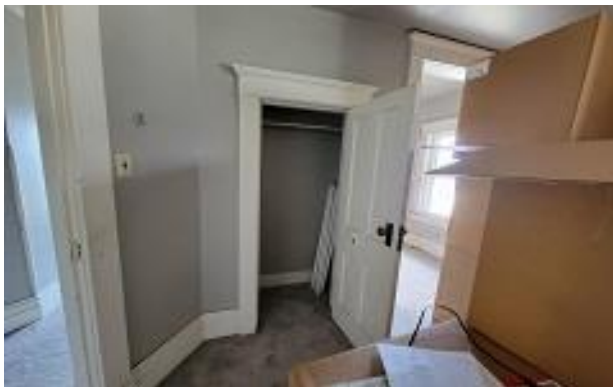
Room 1 door and components and Baseboard

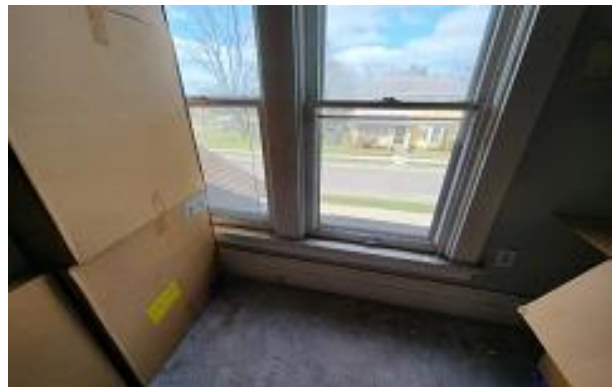
Room 1 window and components

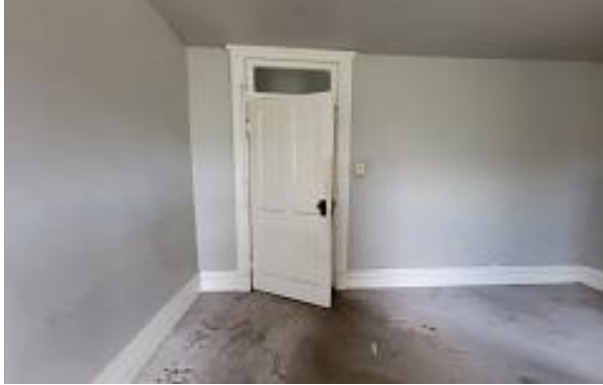
Room 2 door and components

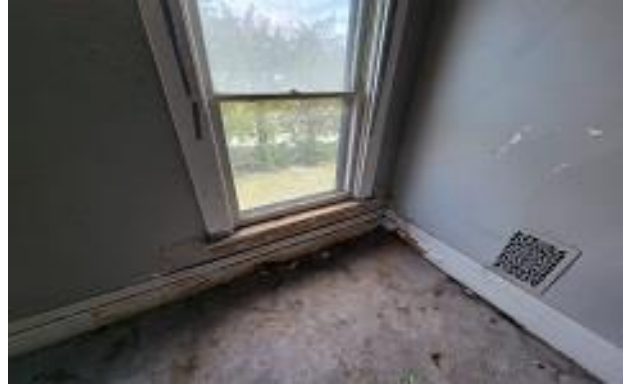
Room 2 window and components and Baseboard

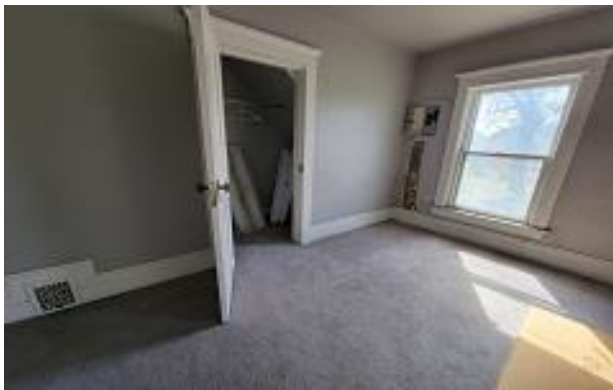
Room 3 door and components, closet Door and components, closet components, Baseboards, and window and components

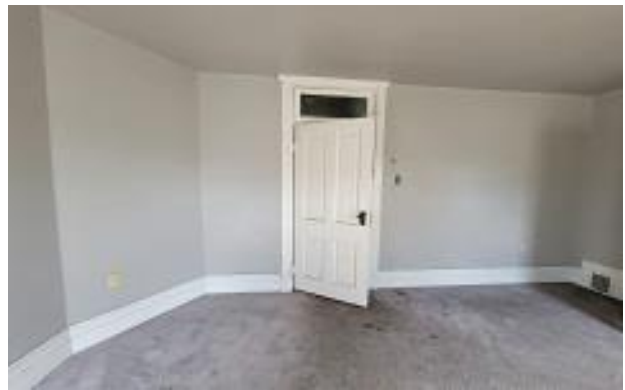
Room 3 door and components

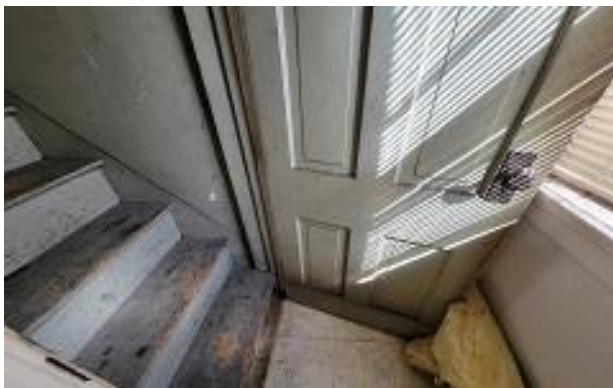
Attic stairway door and jamb

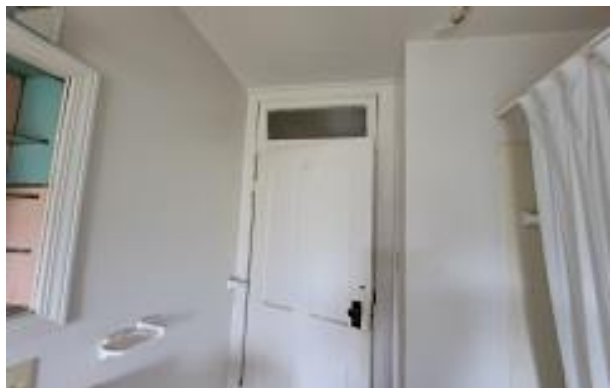
Bathroom door and components

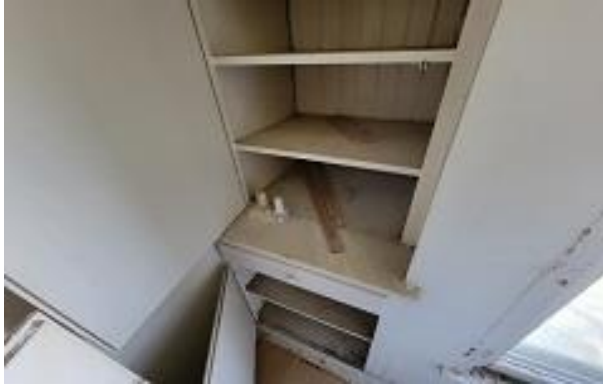
Bathroom B cabinet in and out including Shelves

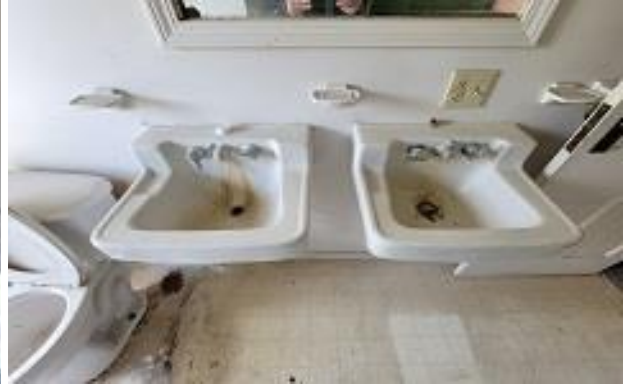
Bathroom sinks (intact)

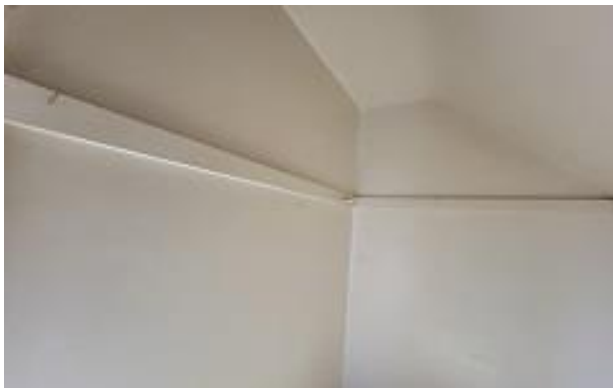
Kitchen closet brackets

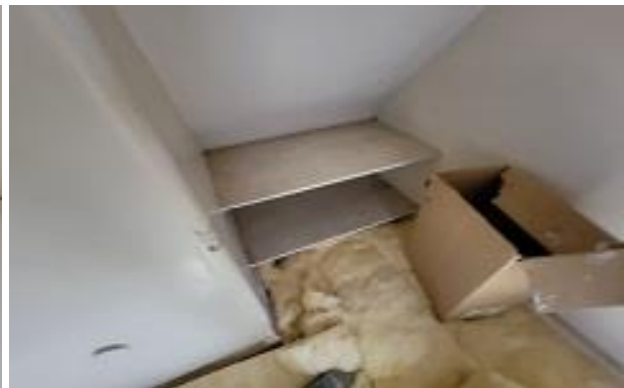
Kitchen closet components

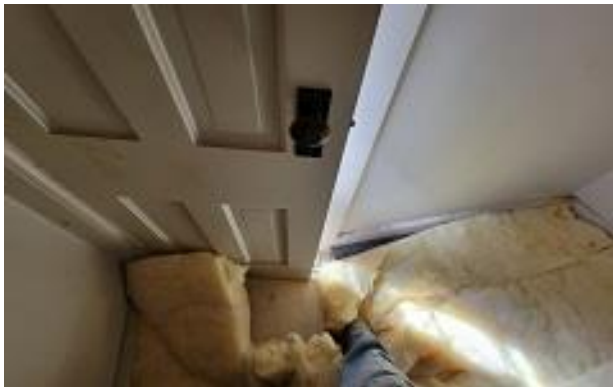
Kitchen closet door and components

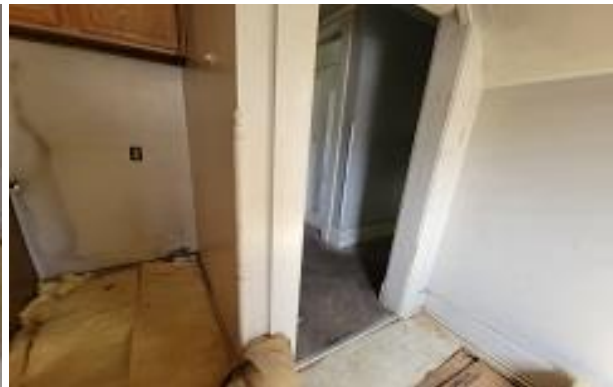
Kitchen A door components

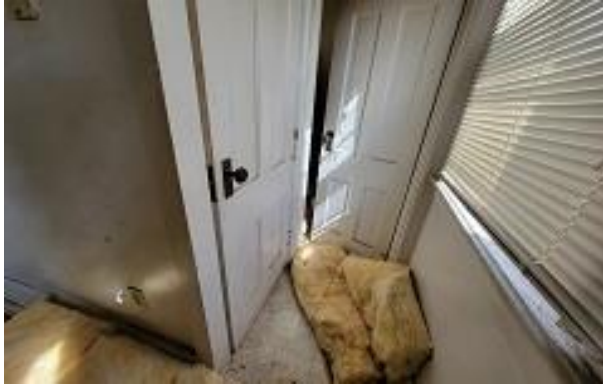
Kitchen AB door and components

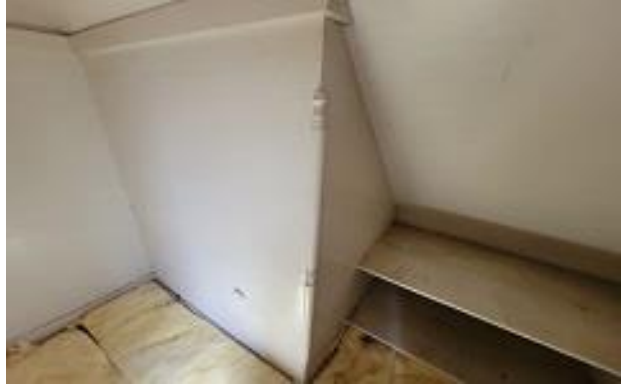
Kitchen B trim (in closet)

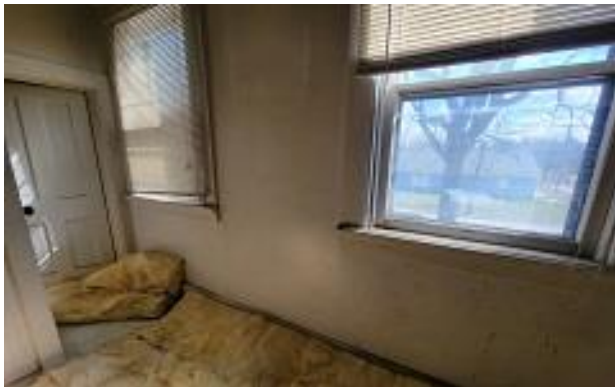
Kitchen C window and components

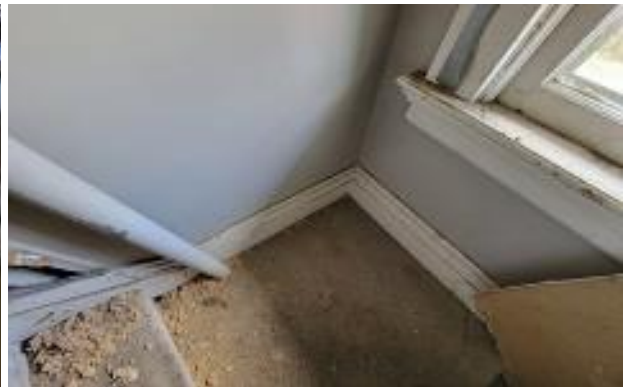
Rear stairway baseboard

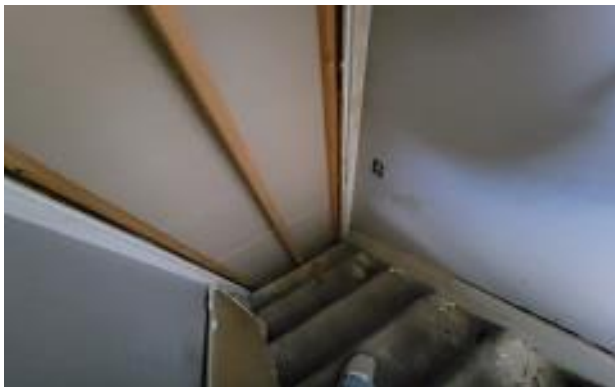
**Rear stairway stringer and door
Components C**

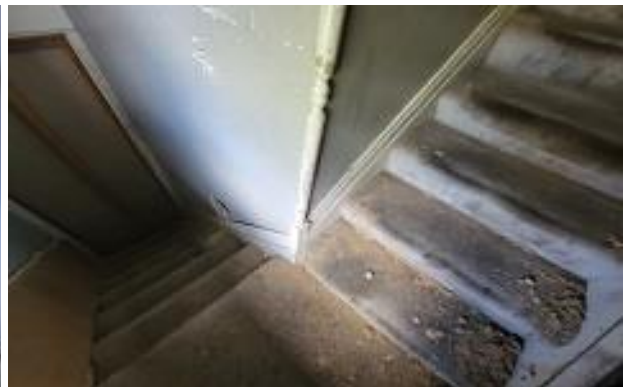
Rear stairway trim AC and stair stringer

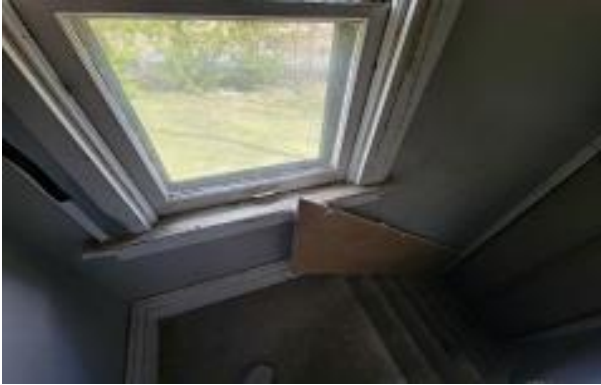
Rear stairway window and components and baseboard
