Limited Visual Assessment and Lead-based Paint Inspection

702 W LaSalle South Bend IN 46601

Inspection Date: August 13, 2020

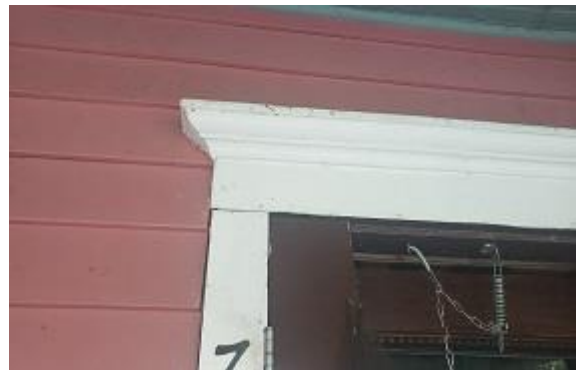
Door components A

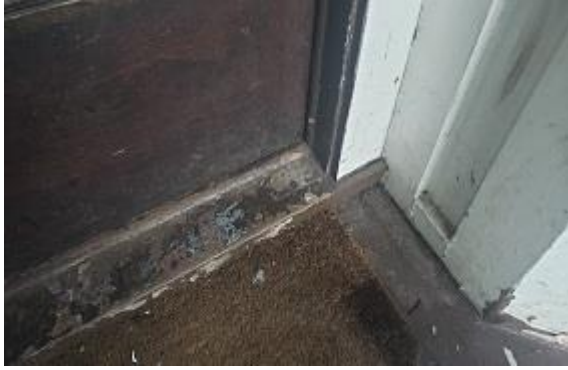
Door threshold A

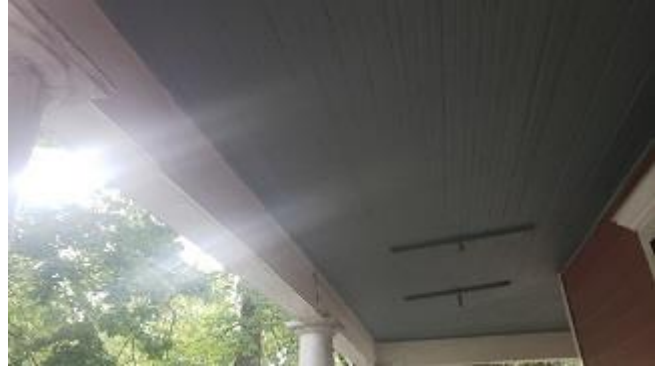
Porch A porch ceiling and porch beam

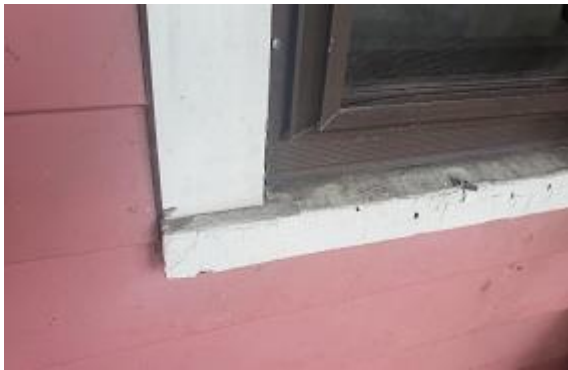
Window and components A

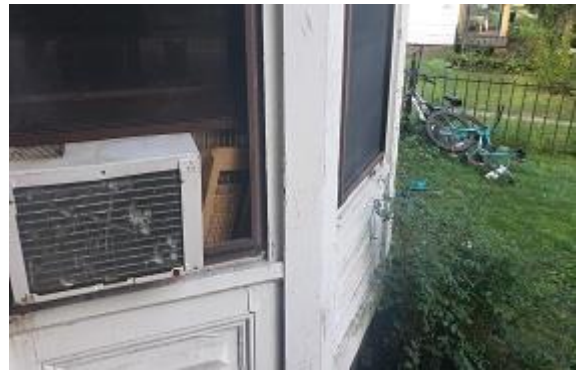
Window and components A

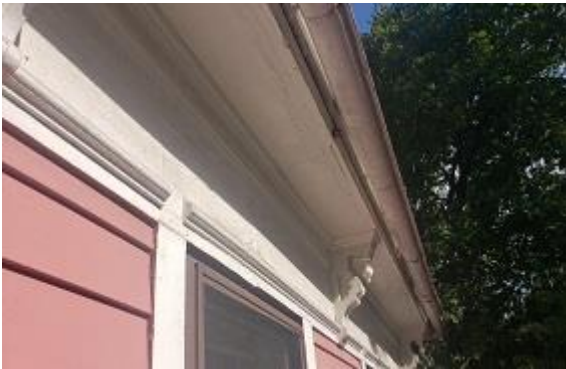
Soffit, fascia, and frieze board ABCD

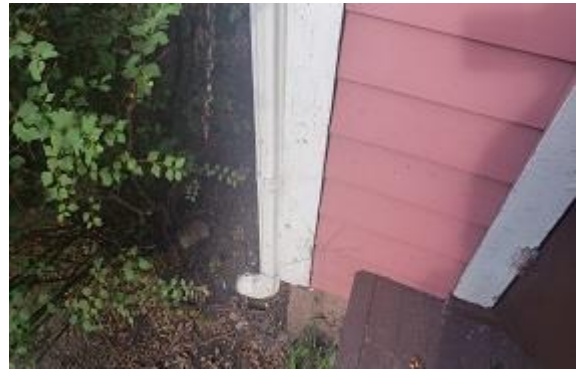
Corner boards ABD

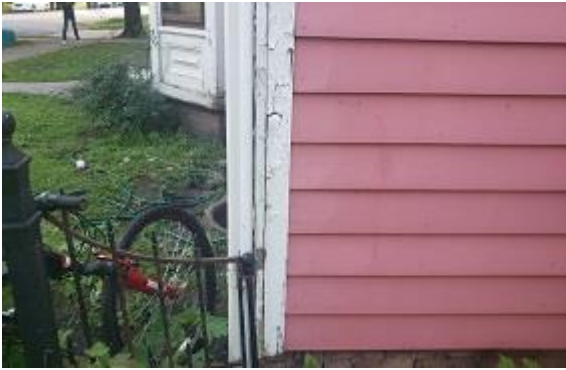
Corner boards AD

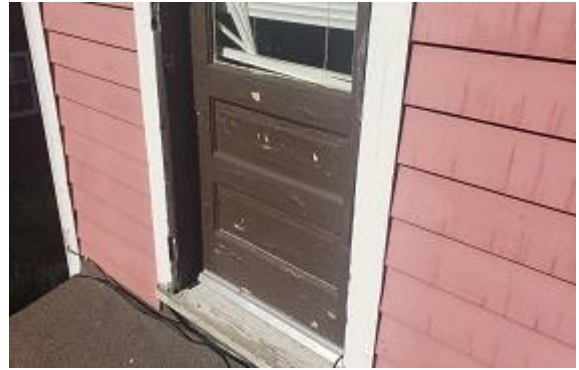
Door and components B (2nd floor)

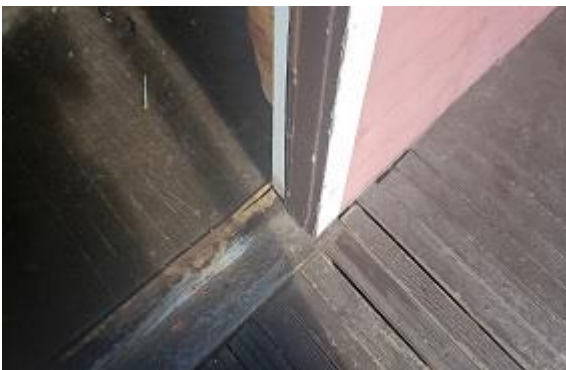
Door components B

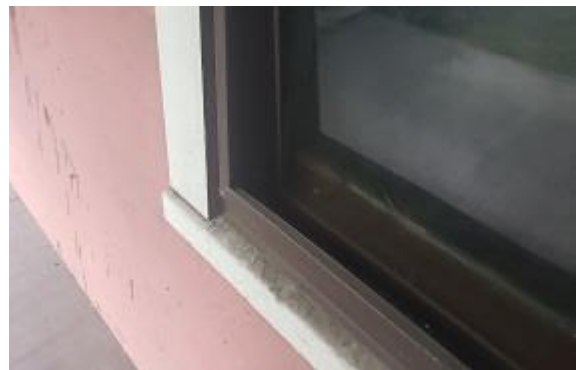
Window and components B

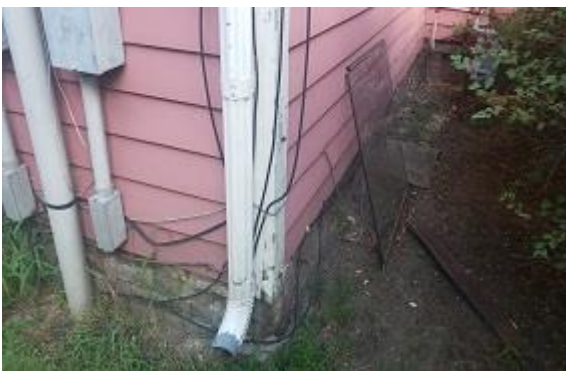
Corner boards BC

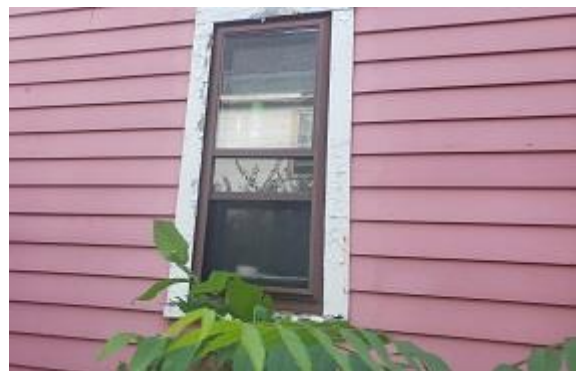
Window and components D
