Limited Visual Assessment and Lead-based Paint Inspection

917 W Colfax, South Bend, IN 46601

Inspection Date: March 25, 2022

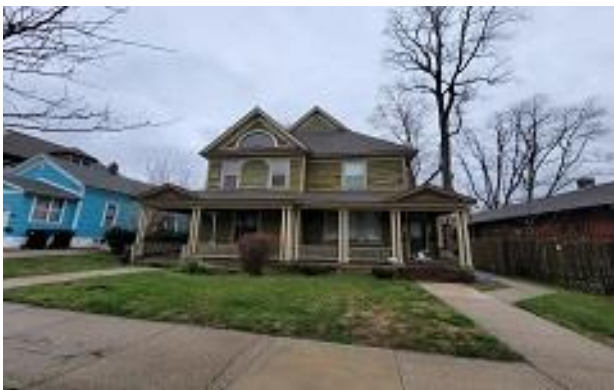
917 W Colfax, South Bend, IN 46601

The property located at **917 W Colfax, South Bend, IN 46601** is a multi-family home (3 units). No written permission was required to access the property. The property was occupied at the time of the inspection. The property is a 2-story residence with an attic and basement built in 1895. The exterior of the house is wood. The windows are wood and vinyl. A photo of the subject location is found below.
