Limited Visual Assessment and Lead-based Paint Inspection

702 W LaSalle South Bend IN 46601

Inspection Date: August 13, 2020

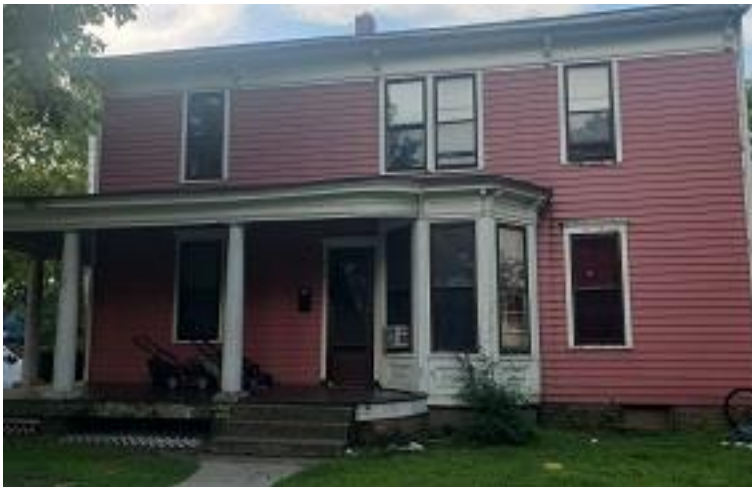
702 W LaSalle South Bend IN 46601

The property located at **702 W LaSalle South Bend IN 46601** is a single-family home (2 units). No written permission was required to access the property. The property was vacant at the time of the inspection. The property is a 2-story residence built in 1862. The exterior of the house is wood. The windows are wood. A photo of the subject location is found below.
